# The Hubble Space Telescope Optical Systems Failure Report

November 1990

National Aeronautics and  
Space Administration

**THE HUBBLE SPACE TELESCOPE**  
**OPTICAL SYSTEMS FAILURE REPORT**

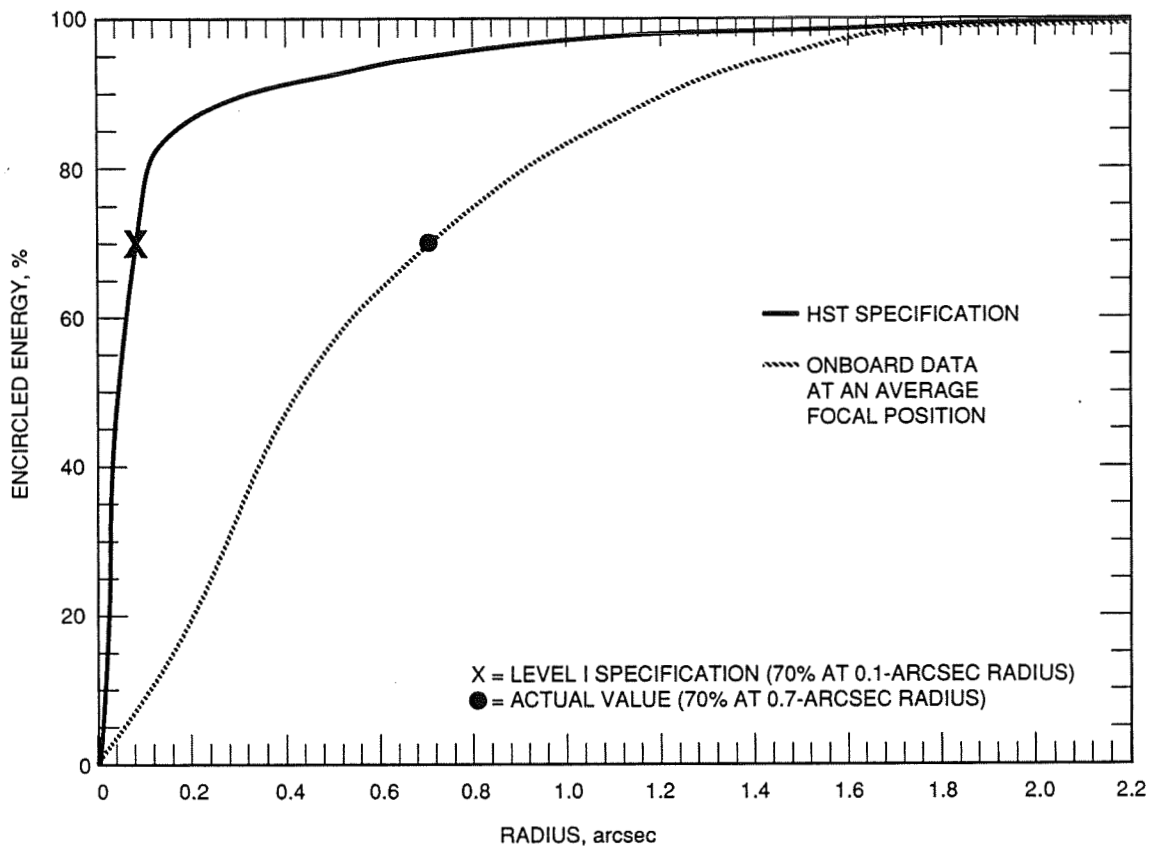
Spherical aberration distorts a point source image (e.g., a distant star) by broadening the image and surrounding it with concentric diffraction rings. This broadening effect prevents distant, closely spaced objects from being separated in the image. A tutorial on spherical and coma aberration is given in Appendix C.

**Figure 5-1. Encircled energy versus arcsecond radius of image produced by the HST.**

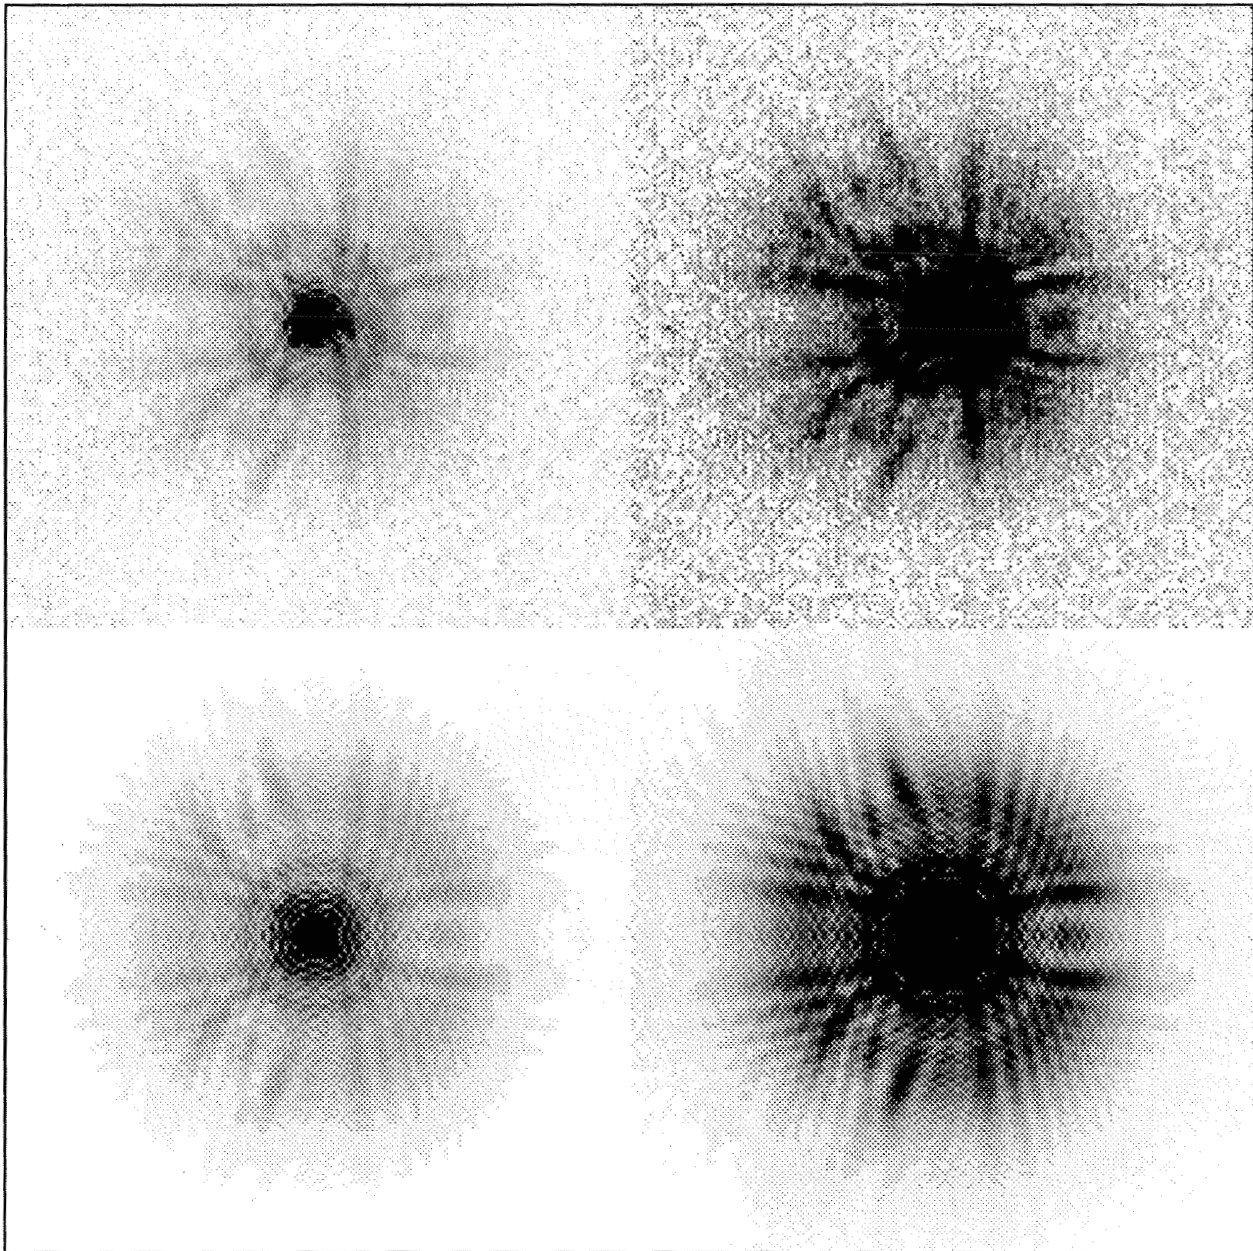
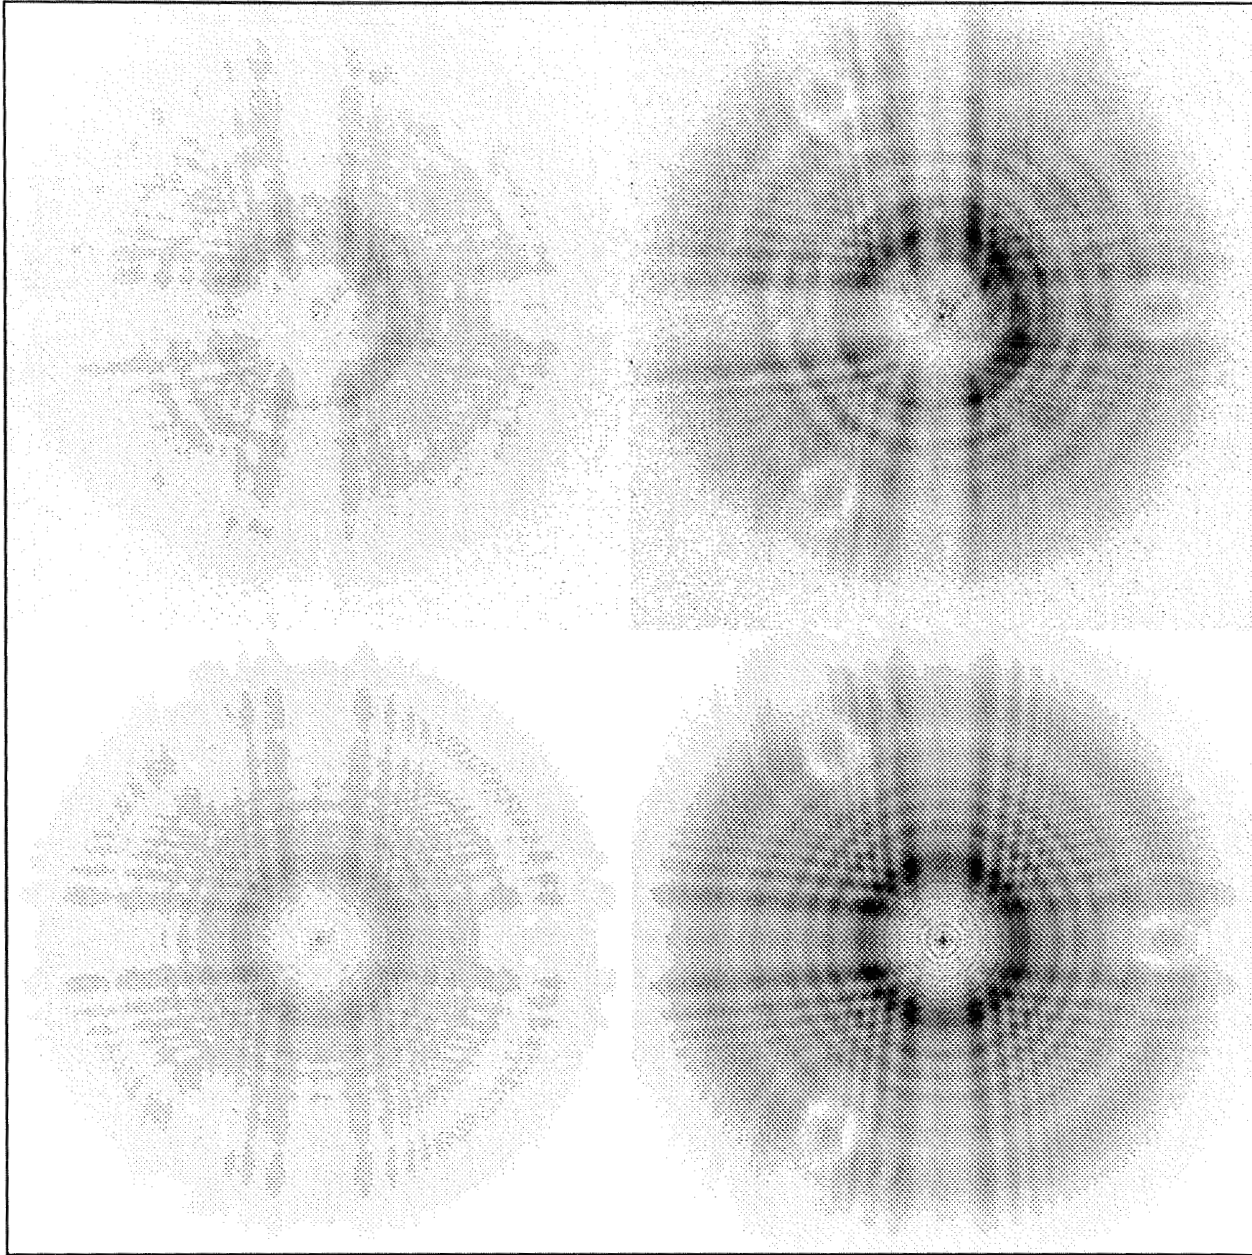
(a) Recorded image of the PC5 star taken on June 14, 1990, with a 0- $\mu\text{m}$  inside focus.

Figure 6-1. Planetary Camera images versus computer simulations. The images in the top frames were taken with the Planetary Camera; those in the bottom frames are computer simulations created using an optical model with 0.5-wave rms wavefront error at 547 nm.

(b) Recorded image of the PC5 star taken on June 21, 1990, with a  $-300\text{-}\mu\text{m}$  inside focus.

Figure 6-1 (continued). The images in both (a) and (b) show a linear-intensity display on the left, and a logarithmic ("stretched") image display on the right. The focal position denotes the position of the secondary mirror. (Data were supplied by Dr. Jon Holtzman.)

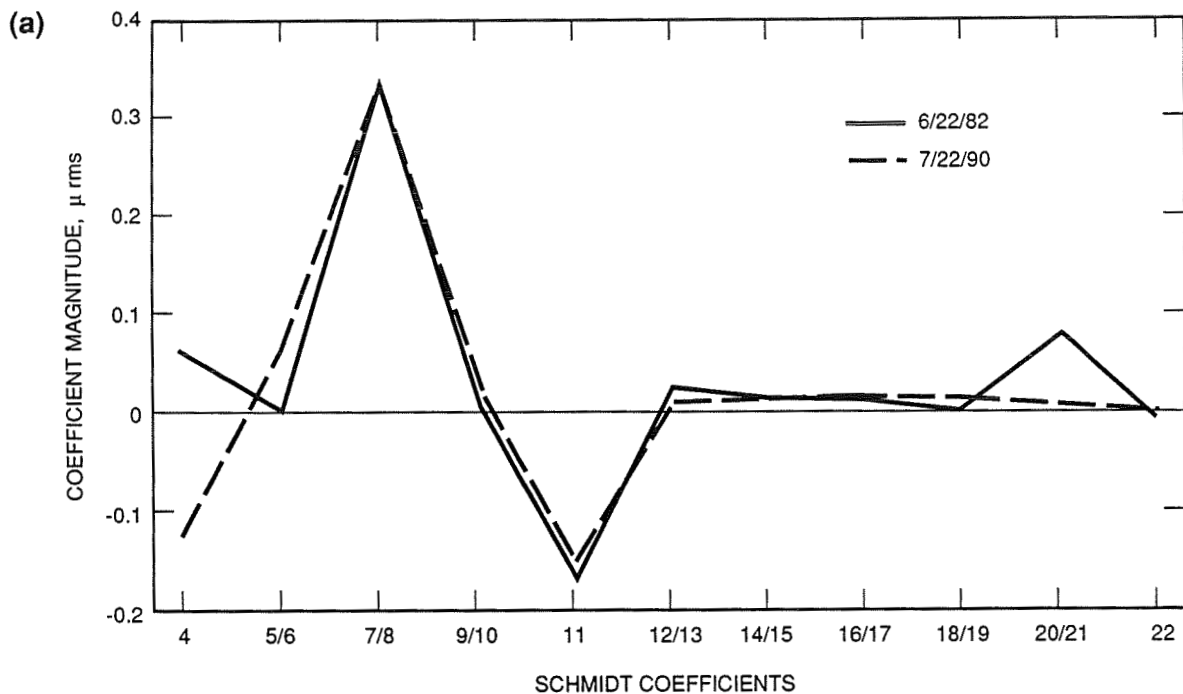
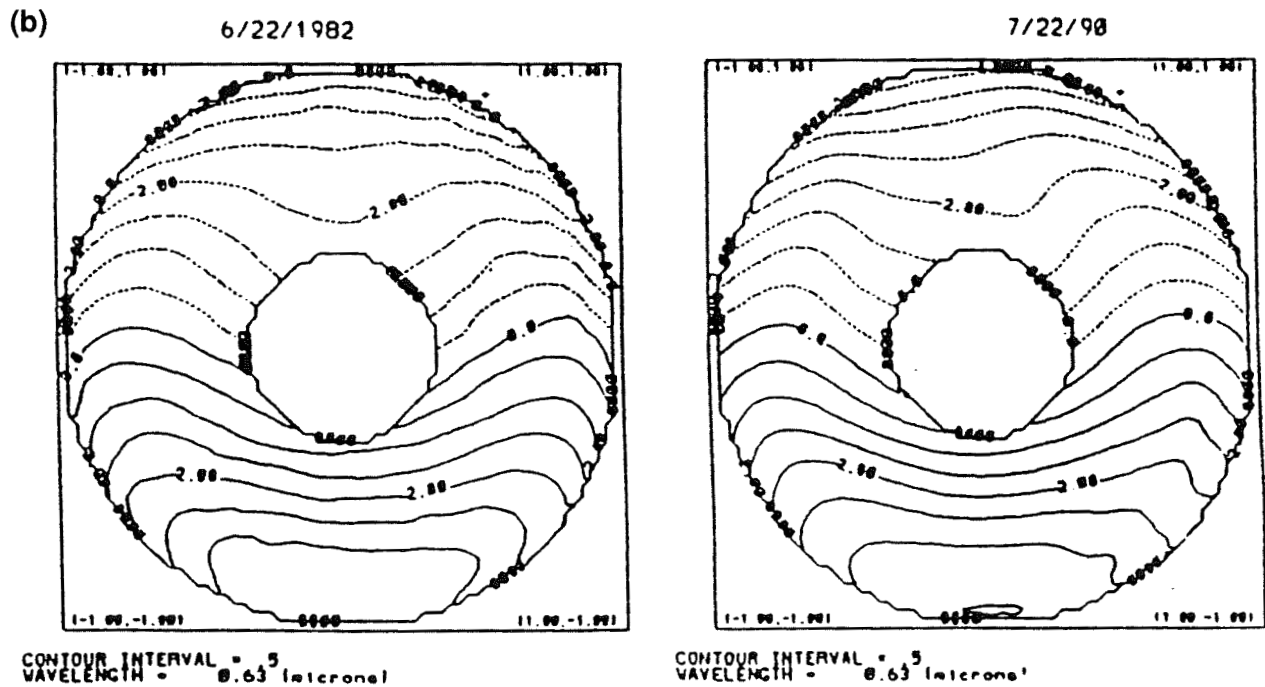
Figure 6-2. Comparison of 1982 and 1990 inverse null corrector data. (a) The coefficients which define the magnitude of various distortions to the wavefront were measured by the INC when it was inserted in front of the RNC in 1982 and in 1990. (b) The coefficient data were extracted from these plots of the interferograms.

The amount of spherical aberration introduced by the INC error is only a small amount compared to the amount of spherical aberration actually measured.

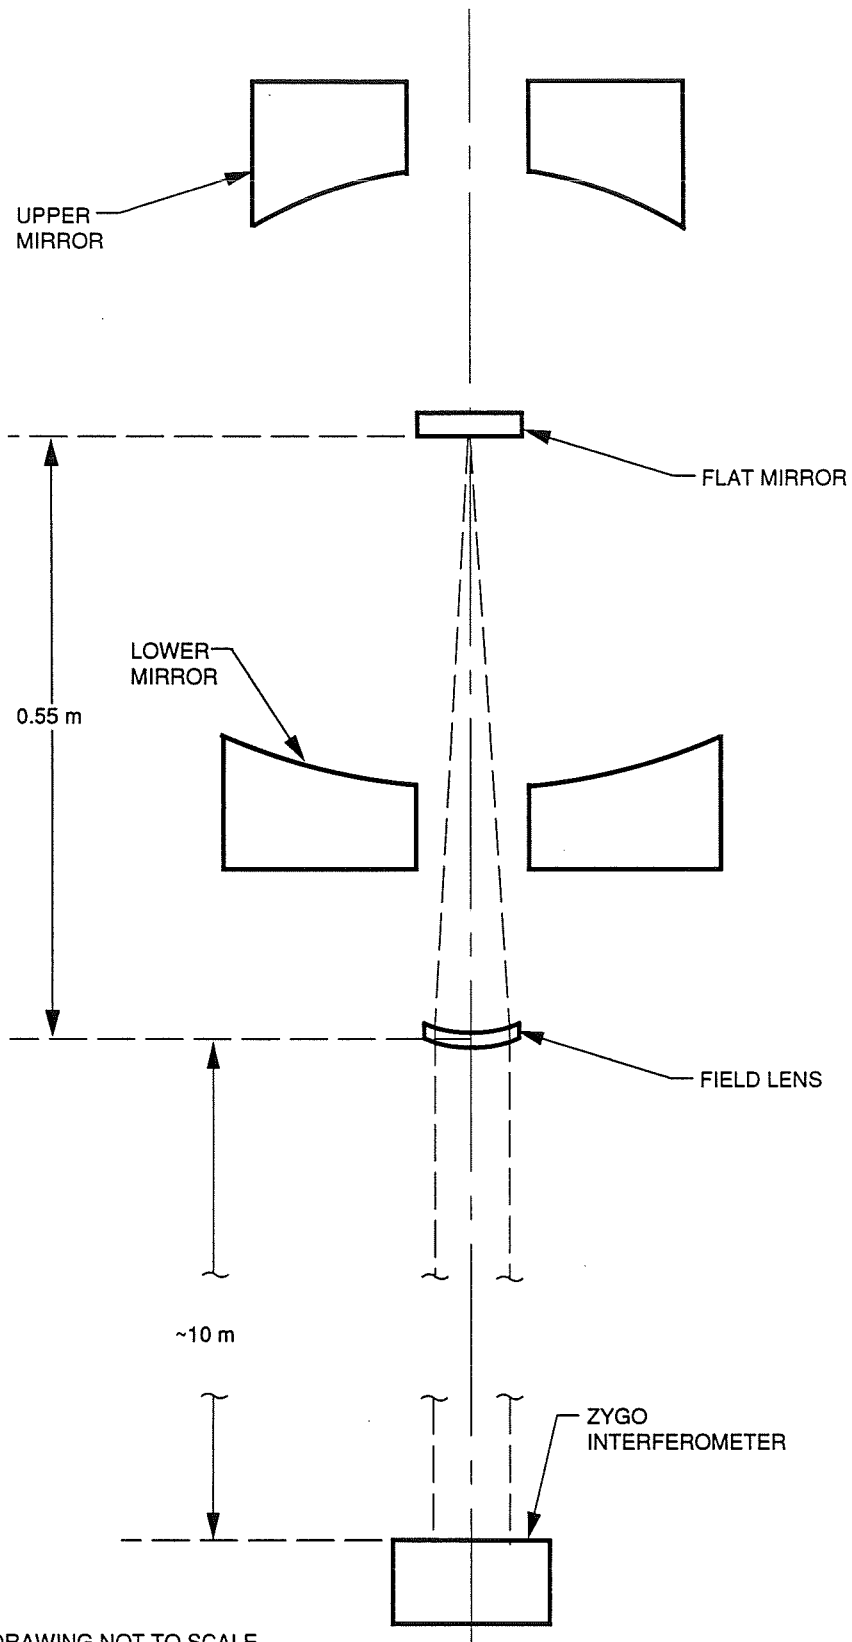
The optical element spacing was measured in 1990 by shining collimated light up through the field lens using a Zygo interferometer as the source, and by placing a flat mirror at the focus of the field lens (a distance of about 0.55 m above the lens). The correct position of the mirror was determined by using the interferometer to find the best focus (Figure 6-3). The distance from the flat mirror was then measured down to the vertex of the lower mirror using a fixture in the mirror hole for a reference. This measurement showed that the field lens was about 1.3 mm too far from the lower mirror. Both the direction and the magnitude of the spacing error correctly explained the spherical aberration observed in the HST image data. The spacings of the other optical elements in the RNC were measured and were found to be correct.

**Figure 6-3. The 1990 spacing measurement between the field lens and the lower mirror of the reflective null corrector, using an optical test.**

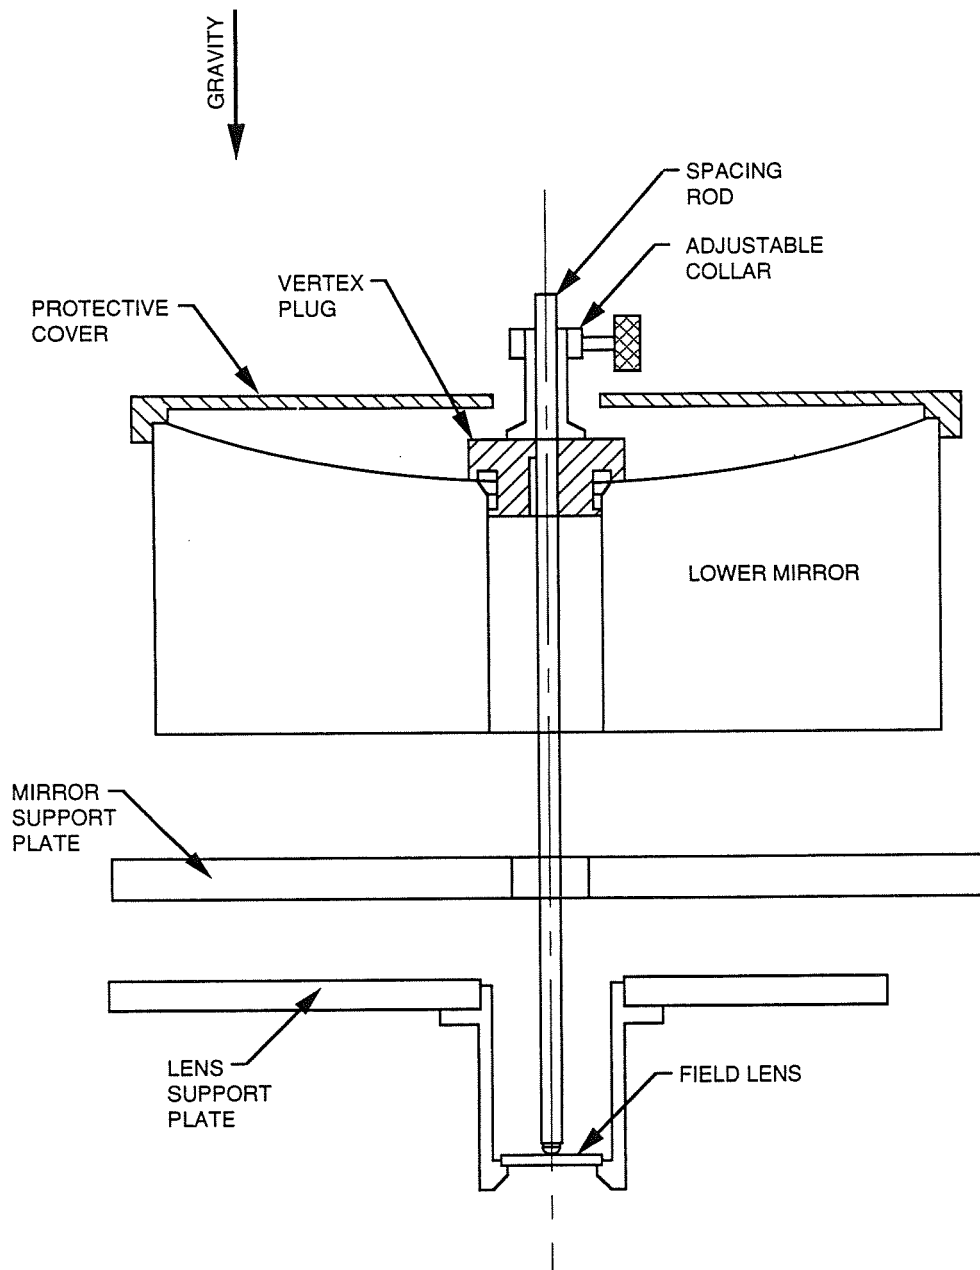
In addition to the optical test used to detect the field-lens spacing error, a direct physical measurement was made from the field lens to the vertex of the lower mirror (Figure 6-4). A lightweight spacing rod and a new vertex plug were made. The results verified the previously measured spacing error to  $\pm 0.1$  mm. More accurate measurements of the displacement error will be done at a later time, as this information is necessary for an accurate determination of a prescription for the recovery optics.

**Figure 6-4. The 1990 spacing measurement between the lower mirror vertex and the field lens of the reflective null corrector, using a mechanical technique.**

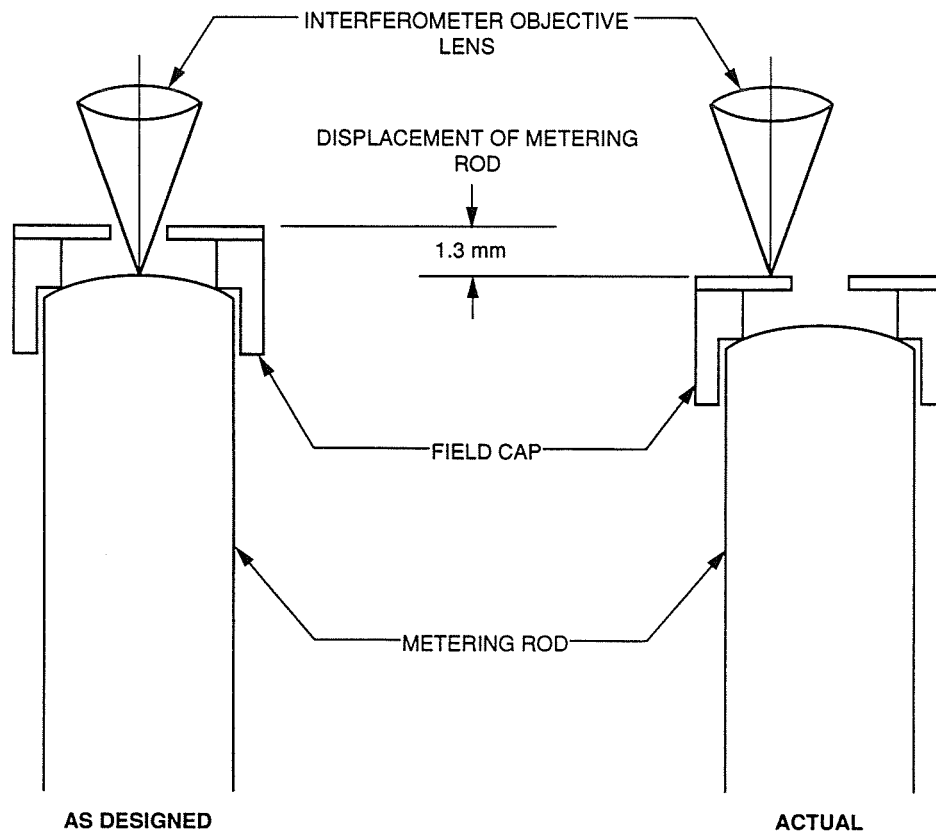
With one end of the metering rod presumably located at the center of curvature of the lower RNC mirror, the field lens was then brought up to the end of rod B, but there was no adjustment left in the screws used for this positioning. More adjustment room was made by inserting spacers between the field lens and the lower mirror mounting plate. The adjustment mechanism was found not to be staked. Staking, i.e., securing the mechanism to prevent inadvertent movement, was a specified procedure. The final location of the field lens was then set with the addition of the spacers. As a result, the field lens was about 1.3 mm too far from its correct position relative to the lower mirror.

**Figure 7-4. Displacement due to the interferometer focusing on the field cap instead of the metering rod.**

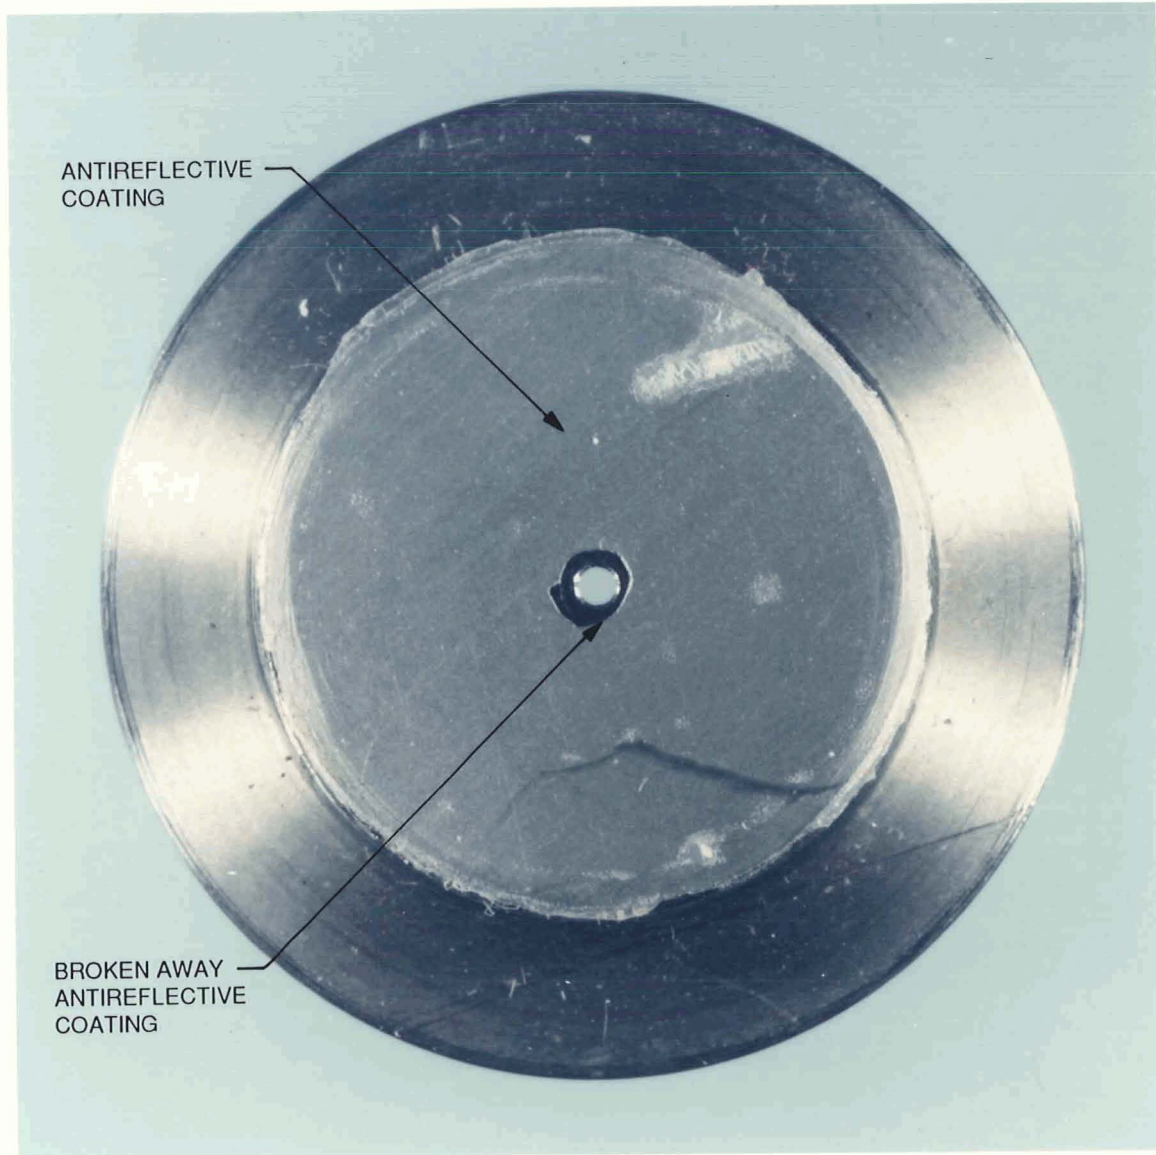
The top surface of the field cap was covered with nonreflecting material; however, some of this material had, apparently inadvertently, broken away from a small area around the field cap aperture. It appears that the operator obtained reflection from the field cap where the nonreflecting material was absent, rather than the rod end, causing the 1.3-mm misspacing. A test performed in 1990 with the equipment showed that it was quite easy, even probable, to make this error with the configuration used. Figure 7-4 indicates how the displacement error occurred by reflecting light off the field cap, rather than the rod end, as designed. Figure 7-5 is a photograph of the field cap and shows the specular region around the aperture. (In this photograph, the broken-away coating appears darker than the surrounding region.)

**Figure 7-5. Top view of the field cap, showing the aperture and the area where the antireflective coating had broken away.**

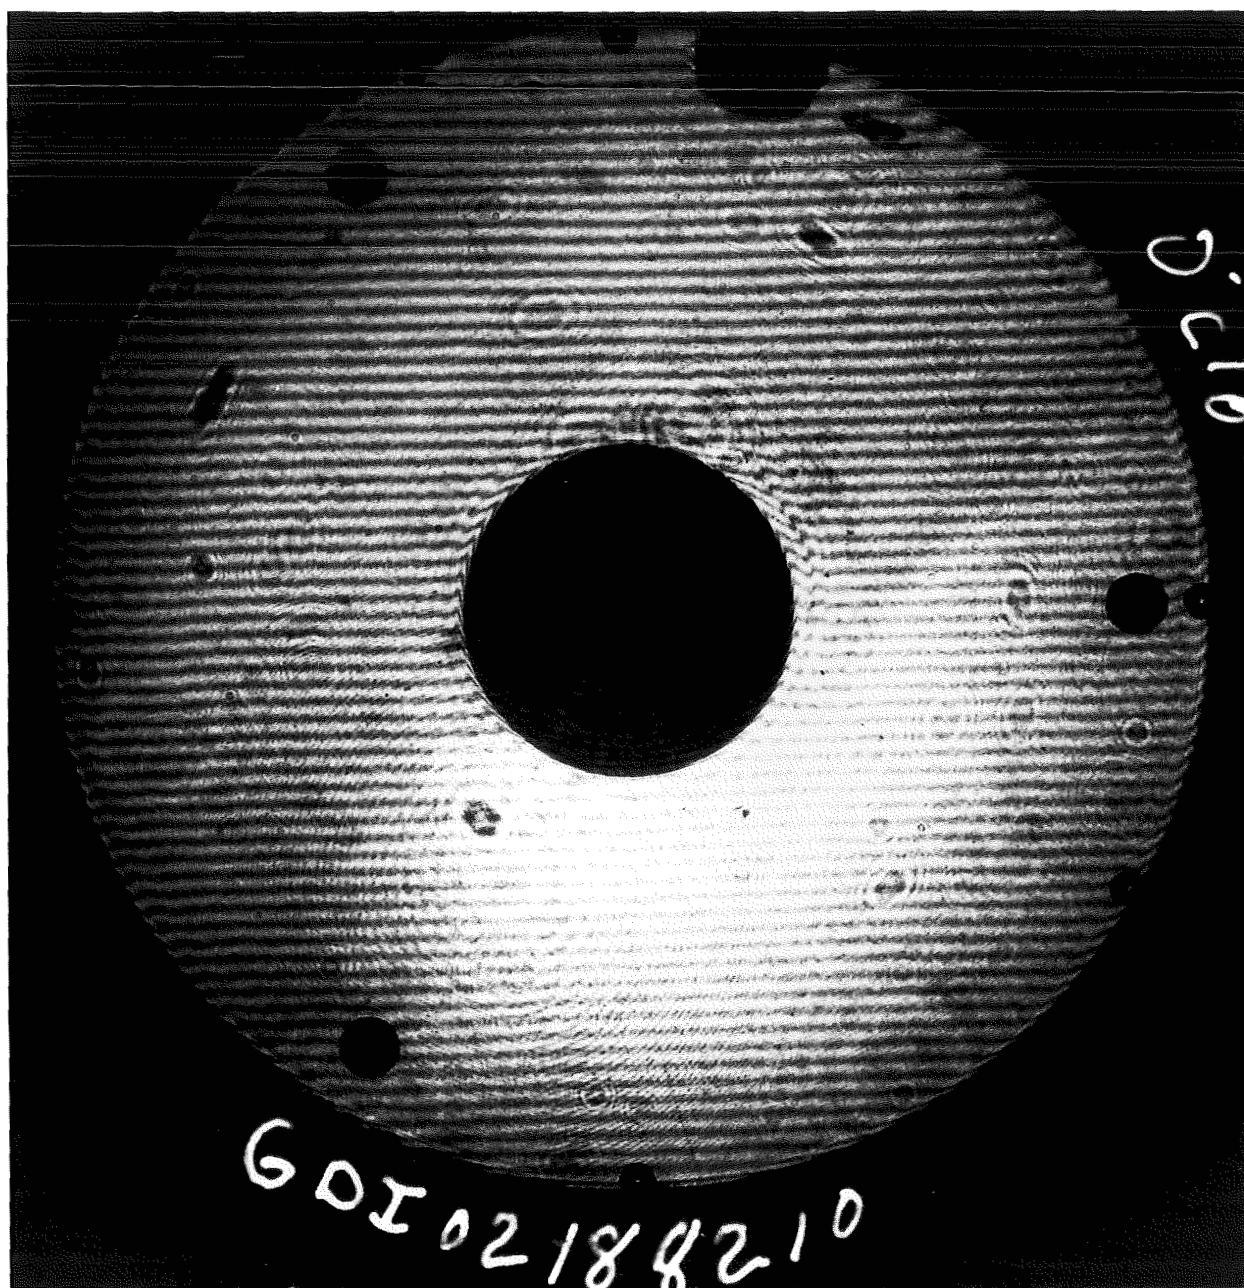
This interferogram shows three circular obscurations that cover penetration holes in the mirror surface. The obscurations were not directly part of the mirror support system, but they covered catch plates that would keep the mirror from breaking loose of the mount and damaging portions of the space shuttle orbiter, should the shuttle have had to abort the flight and return to Earth in an emergency landing. The fringe pattern also indicates the presence of local, sharp surface errors that actually fall outside of the clear aperture being used in the telescope. The semicircular marks at the periphery are fiducials used to locate the aperture in the fringe digitization process. The other defects indicated in the picture are glass chips and marks attached to components in the reflective null corrector.

**Figure D-1. RNC interferogram of the primary mirror, taken in February 1982.**
