# The Hubble Space Telescope Optical Systems Failure Report

November 1990

National Aeronautics and  
Space Administration

**THE HUBBLE SPACE TELESCOPE**  
**OPTICAL SYSTEMS FAILURE REPORT**

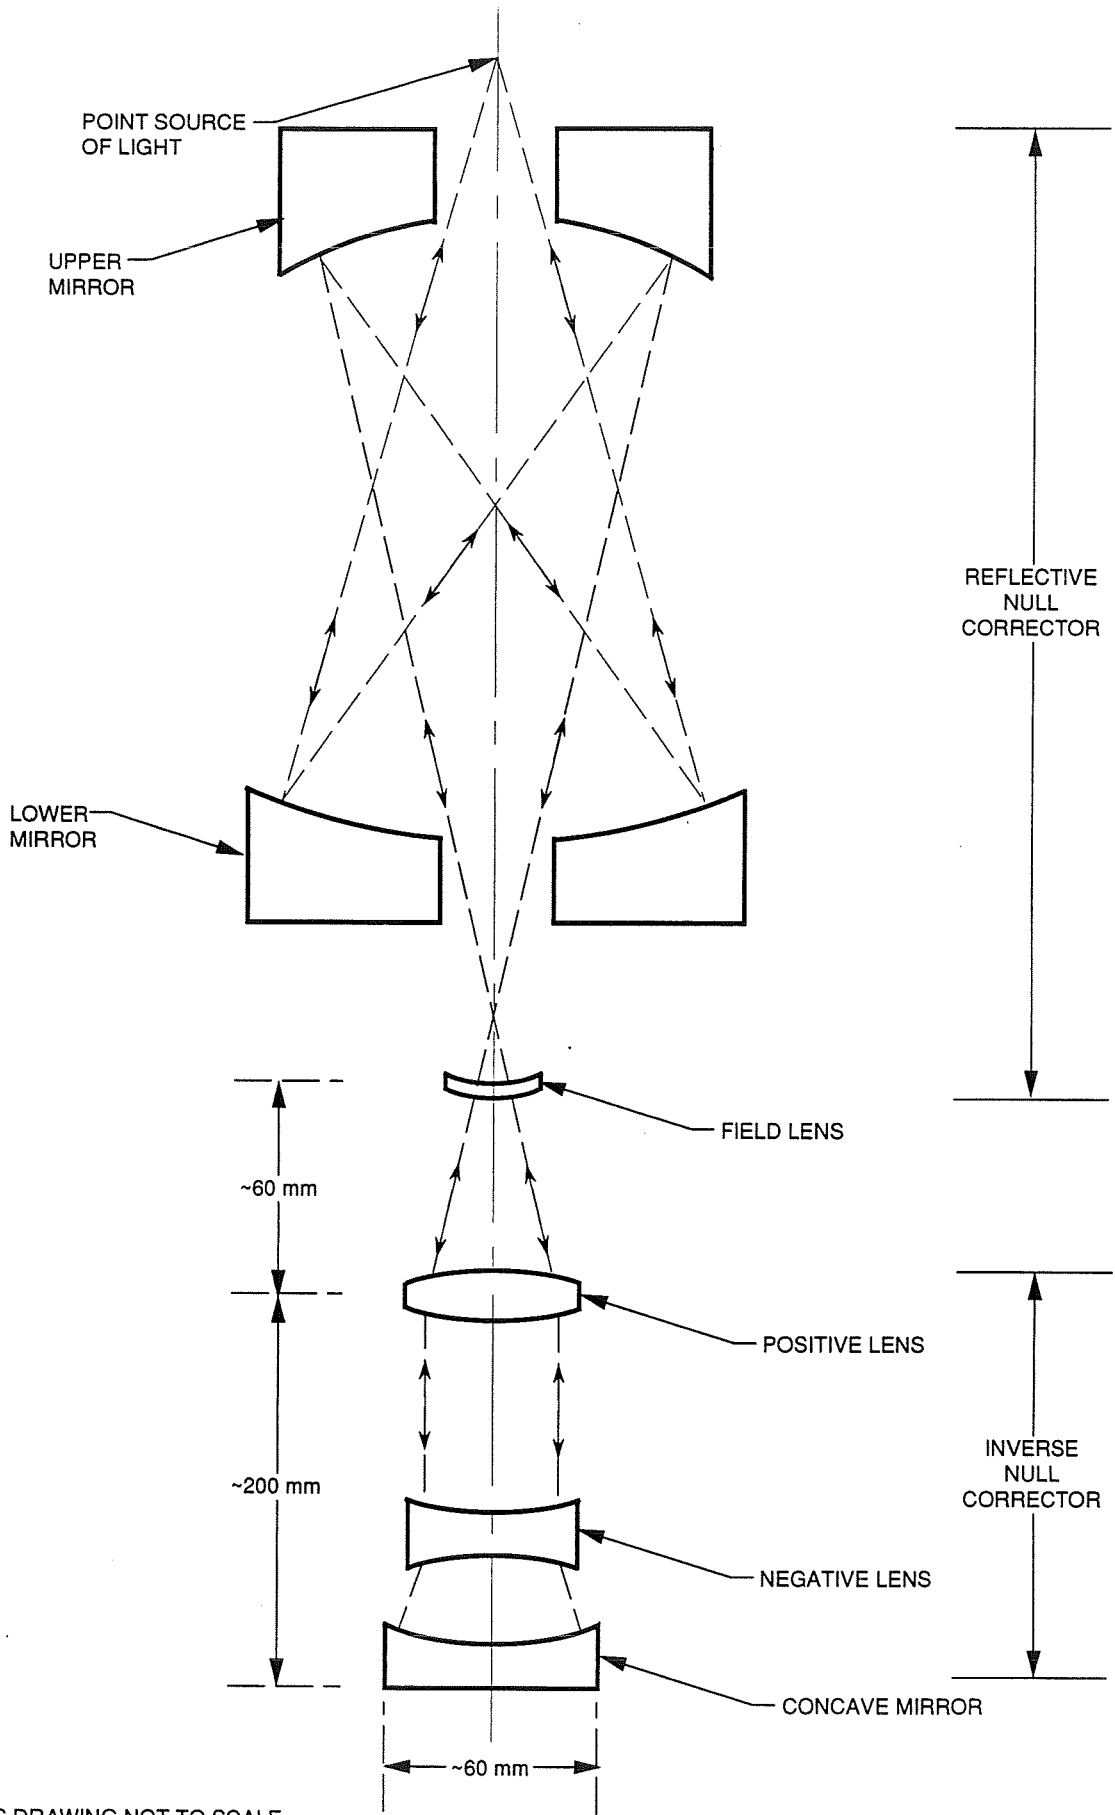
As a check on the position of the Coaxial Reference Interferometer (CORI) used with the RNC, an inverse null corrector (INC) was designed. When swung under the RNC, the INC would simulate a perfect mirror, just as a perfect primary mirror would appear with straight fringes when viewed through the RNC (Figure 4-3).

**Figure 4-3. Inverse null corrector inserted below the reflective null corrector.**

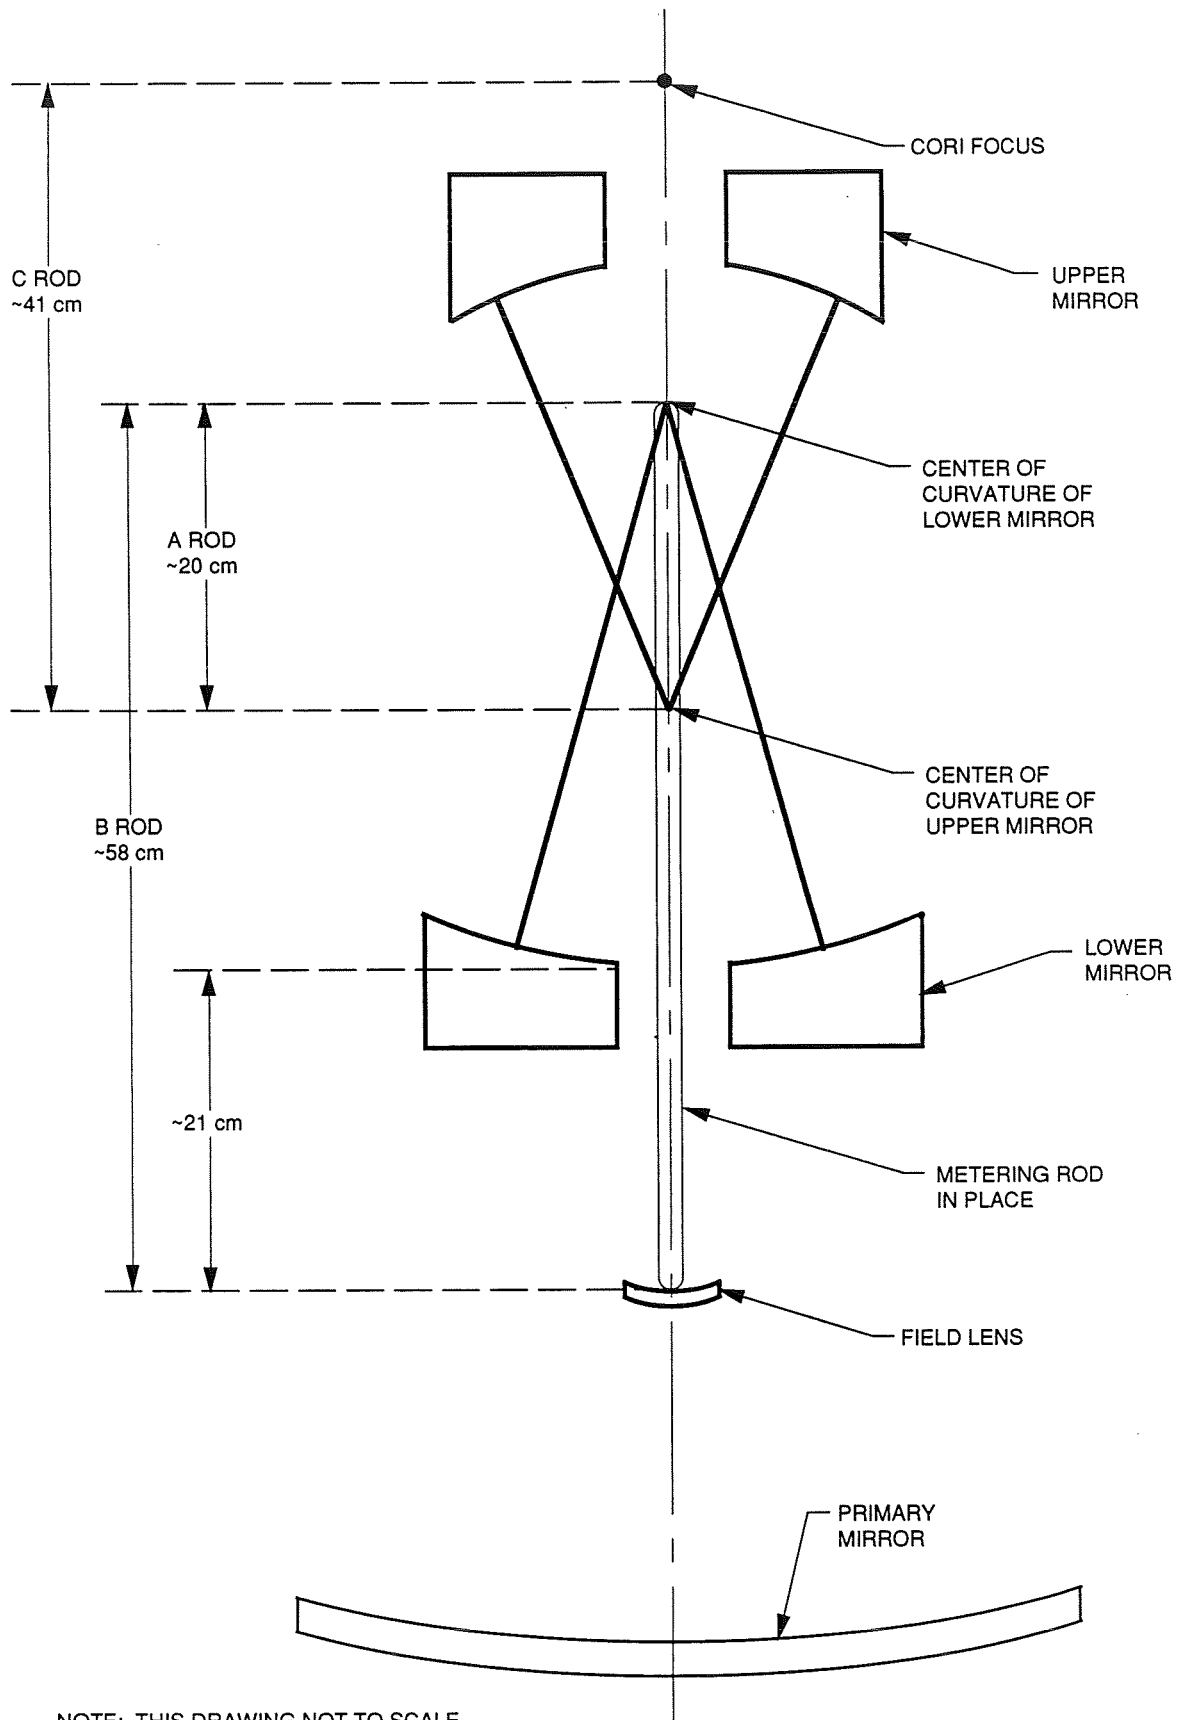
It has been established that the field lens was approximately 1.3 mm too far from the lower mirror of the RNC, which was used to figure the primary mirror. The RNC and its associated interferometer were found in the test chamber, unused and unchanged since the completion of the HST program. The RNC was measured in situ, and there is high confidence that the spacing error existed during the fabrication and test of the HST primary mirror. The cause of the spacing error, on the other hand, becomes a matter of conjecture, because the records necessary to reproduce what actually happened were not found. The scenario given below reproduces the events and provides a rationale of how the spacing error occurred. This scenario was simulated in the laboratory under the guidance of the Board and is the most likely cause of the error.

At the beginning of the program to build the 2.4-m Hubble primary mirror, P-E modified the RNC that had been used in building a 1.5-m mirror prototype. This modification required adding a new field lens and respacing the optical elements to create the correct shape for the larger mirror. Figure 7-1 is a schematic of this RNC, including the positions of the metering rods used to set the optics.

**Figure 7-1. Position of metering rods used to space optical elements in the reflective null corrector.**

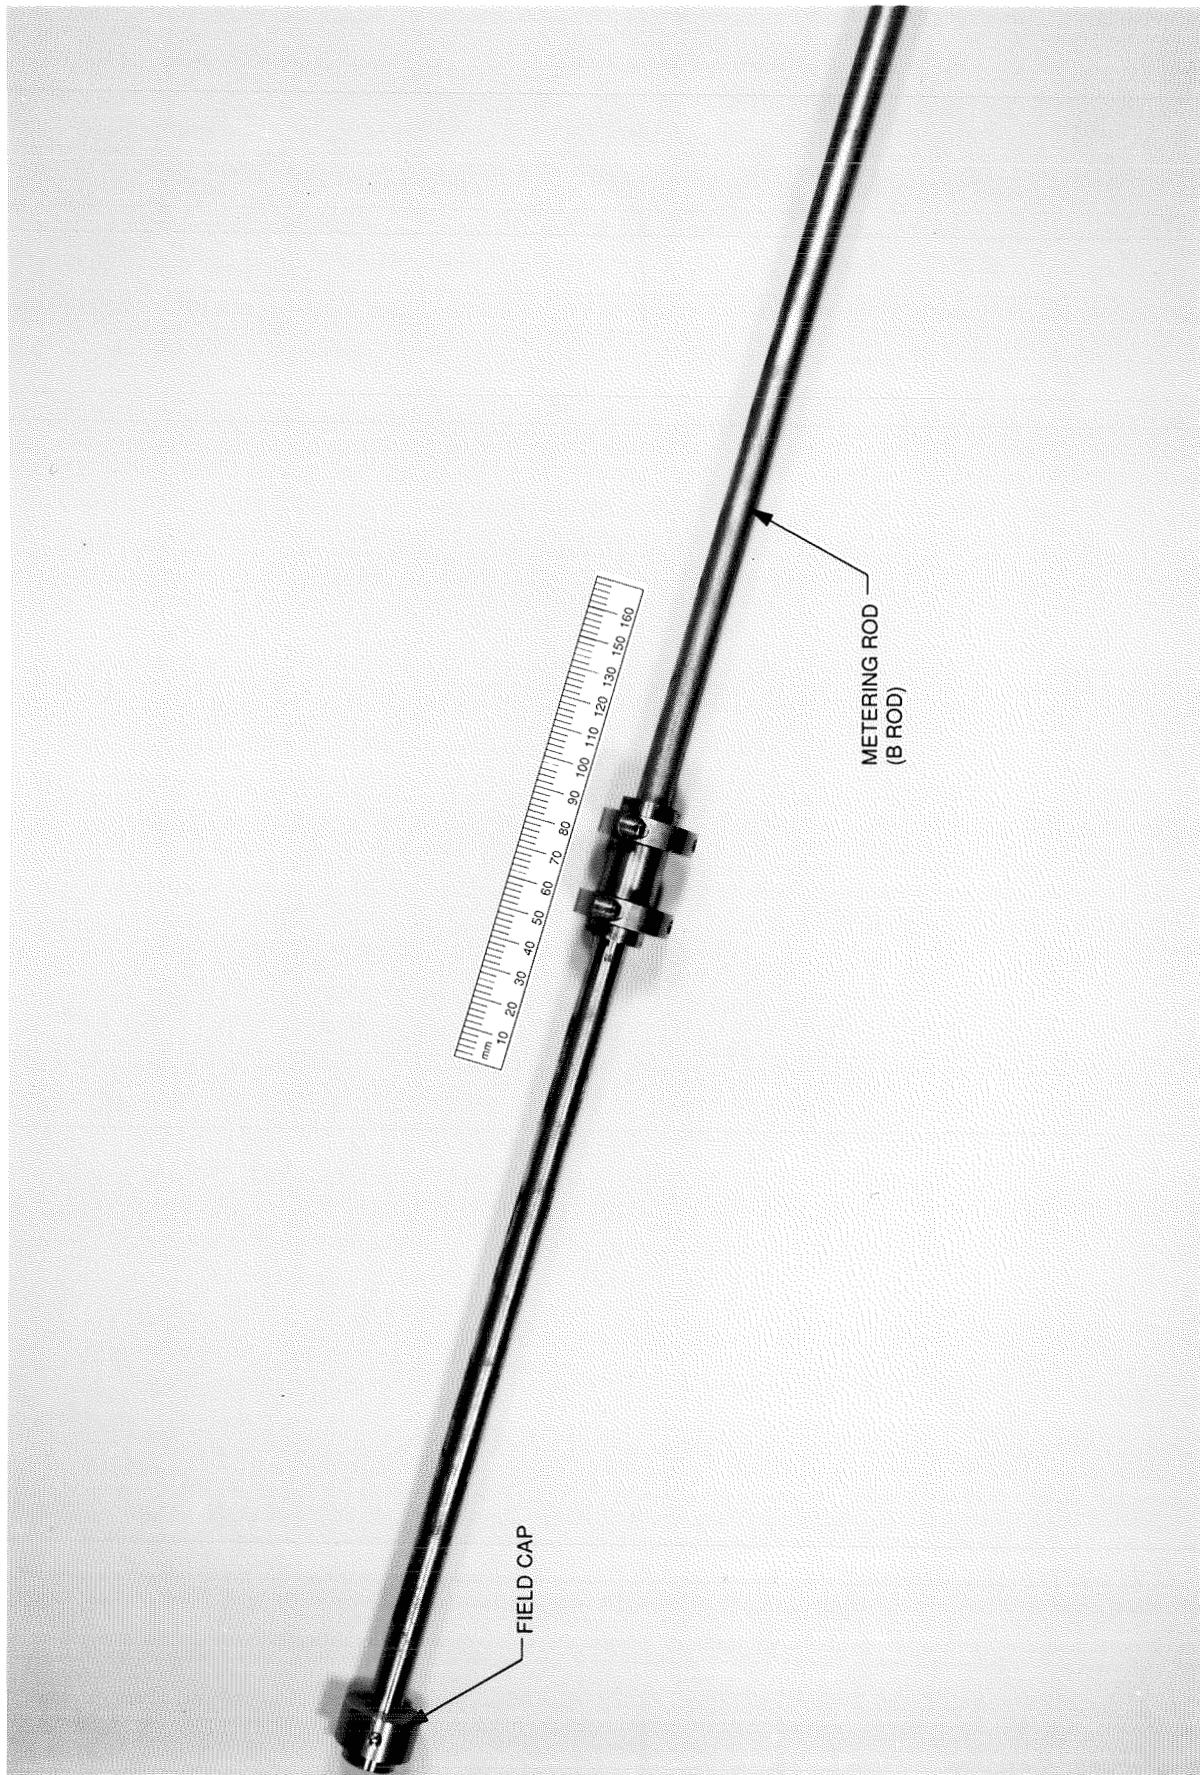
Figure 7-2. Metering rod (B rod) used to space the field lens and the center of curvature of the lower mirror in the reflective null corrector.

With one end of the metering rod presumably located at the center of curvature of the lower RNC mirror, the field lens was then brought up to the end of rod B, but there was no adjustment left in the screws used for this positioning. More adjustment room was made by inserting spacers between the field lens and the lower mirror mounting plate. The adjustment mechanism was found not to be staked. Staking, i.e., securing the mechanism to prevent inadvertent movement, was a specified procedure. The final location of the field lens was then set with the addition of the spacers. As a result, the field lens was about 1.3 mm too far from its correct position relative to the lower mirror.

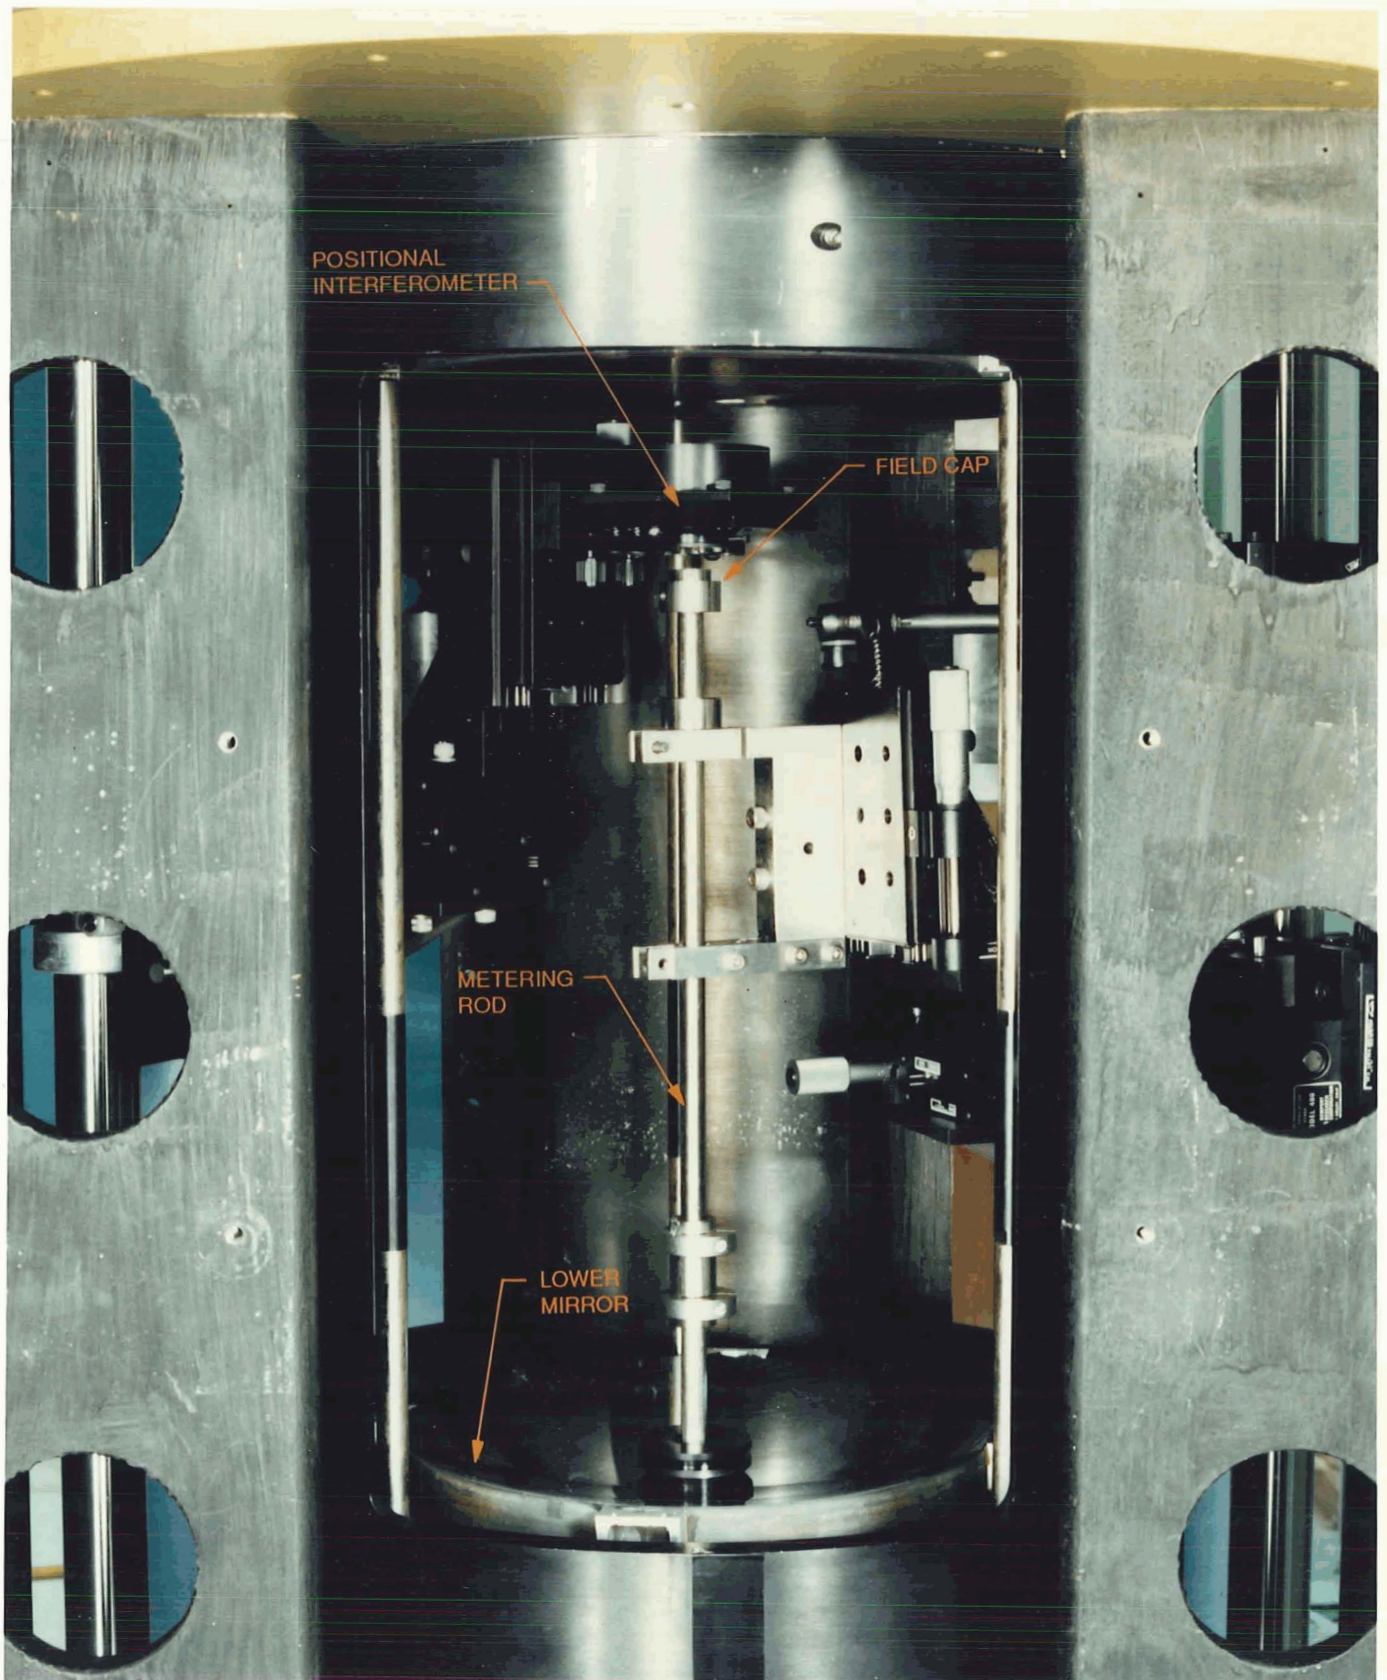
Figure 7-3. Metering rod in position between the field lens and the center of curvature of the lower mirror in the reflective null corrector.

The top surface of the field cap was covered with nonreflecting material; however, some of this material had, apparently inadvertently, broken away from a small area around the field cap aperture. It appears that the operator obtained reflection from the field cap where the nonreflecting material was absent, rather than the rod end, causing the 1.3-mm misspacing. A test performed in 1990 with the equipment showed that it was quite easy, even probable, to make this error with the configuration used. Figure 7-4 indicates how the displacement error occurred by reflecting light off the field cap, rather than the rod end, as designed. Figure 7-5 is a photograph of the field cap and shows the specular region around the aperture. (In this photograph, the broken-away coating appears darker than the surrounding region.)

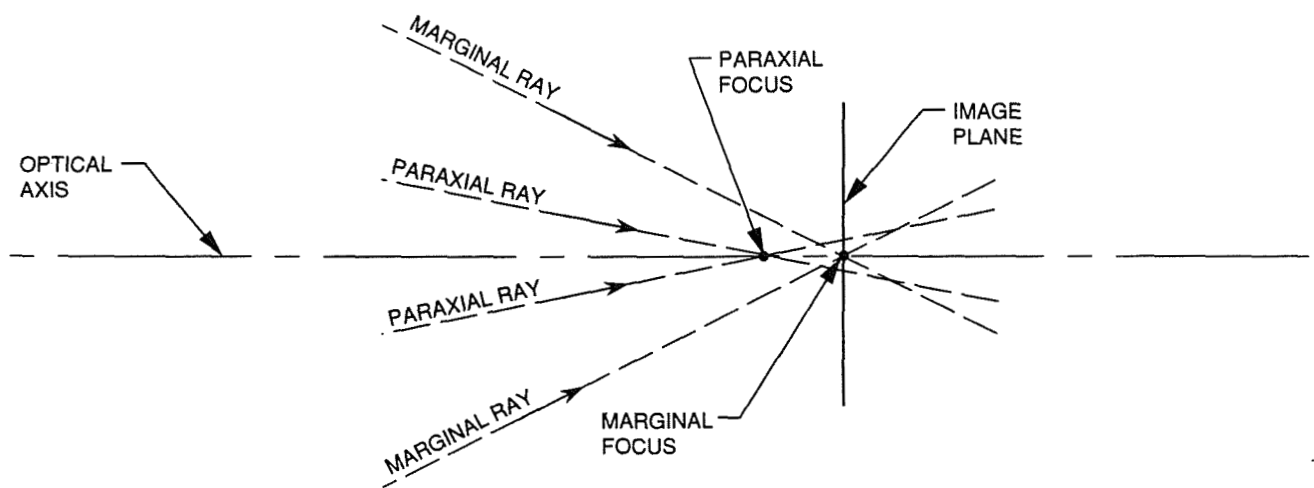
In the case of the HST, the "template" (the reflective null corrector) used to provide the reference surface for figuring the primary mirror, was not correct. In Figure C-4, we show an enlarged view of the marginal and paraxial rays as they converge in the vicinity of the vertex of the HST. Figure C-1 was used to show how the marginal focus could be superimposed on the paraxial focus by removing material. In the HST, too much material was removed from the outer edges of the primary mirror, and the marginal focus was moved to the right, past the paraxial focus. Since the marginal focus is to the right of the paraxial focus, the sign on the error is negative. Since more material than necessary was removed, the opticians call this situation "overcorrected" spherical aberration.

**Figure C-4. Image-plane enlargement of the HST Ritchey-Chretien optical system. In the HST, too much material from the edges of the primary mirror was removed, and the marginal focus was moved past the paraxial focus. This is characteristic of an optical system overcorrected for spherical aberration.**

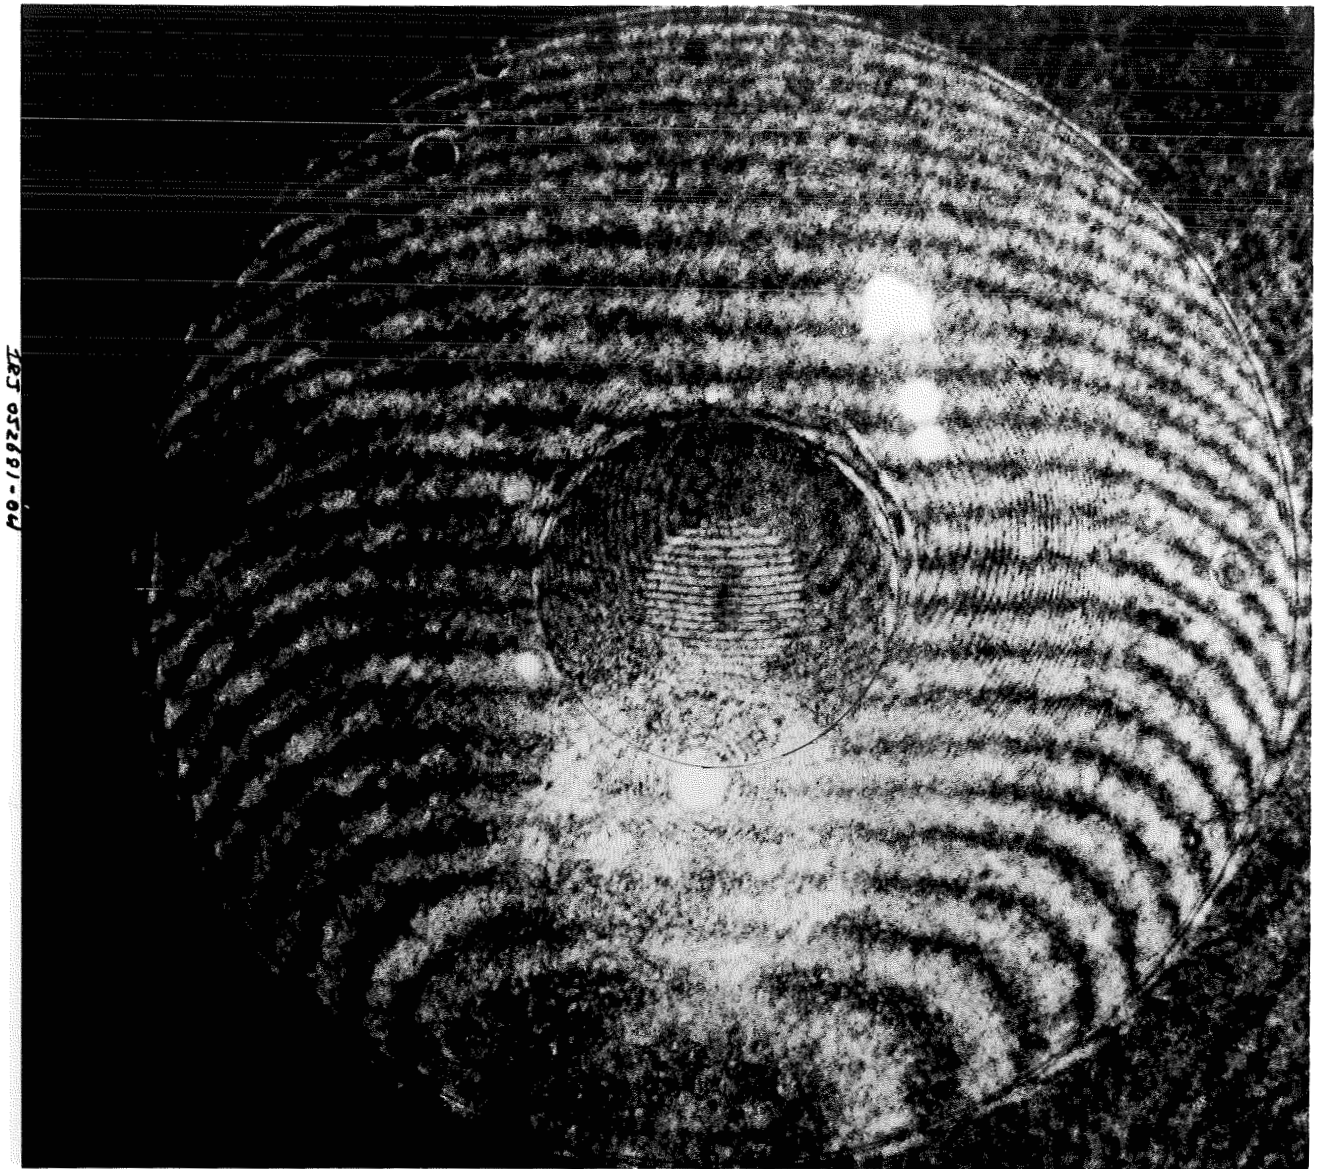
PO-167250 F37

The final test data for the primary mirror, obtained using the reflective null corrector, indicated that the mirror exceeded the specifications. The Board found interferograms relating to the RvNC test (found in Appendix D), which indicated a surface-figure error of about the right magnitude and sign to explain the errors existing in the operational telescope. Since a perfectly polished mirror would have shown no error on either null corrector, it was evident to the Board that an error actually existed in the RNC.

The consistency of the data from the INC and the RvNC indicates the presence of the error in the RNC. The excellent agreement of the INC data taken in 1981 and similar data taken in 1990 indicates the excellent stability of the RNC.

**Figure D-2. RvNC interferogram of the primary mirror, taken in May 1981.**

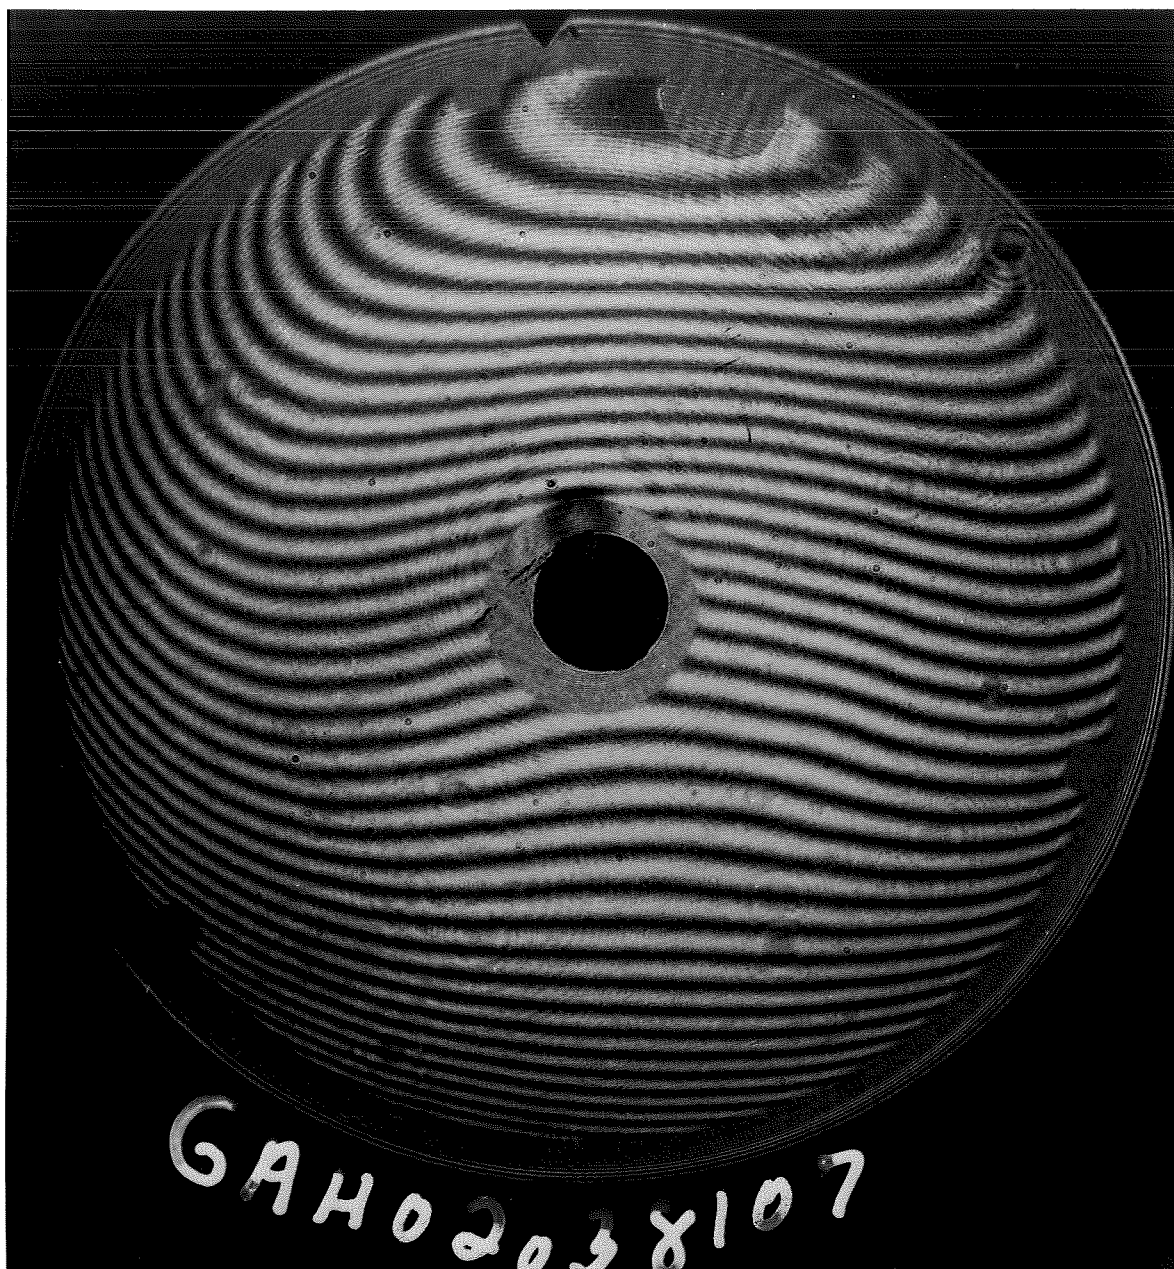
The first test performed on the RNC was to insert the INC and take an interferogram on July 22, 1990. This interferogram was analyzed and compared with a previous interferogram taken with the INC in place. (This latter interferogram was found in a notebook of a P-E employee and was dated June 22, 1982.) Comparison of these two interferograms (Figure 6-2) shows virtually identical results, clearly indicating the existence of spherical aberration. These INC interferograms are corroborated by the RvNC interferograms, which also show spherical aberration (as discussed in Appendix D, Figure D-2). The combination of these interferograms led the Board to conclude that the CORI/RNC assembly is now essentially in the same state of operation as it was at the time the final measurements were made on the primary mirror.

**Figure D-3. INC interferogram of the reflective null corrector, taken in February 1981.**

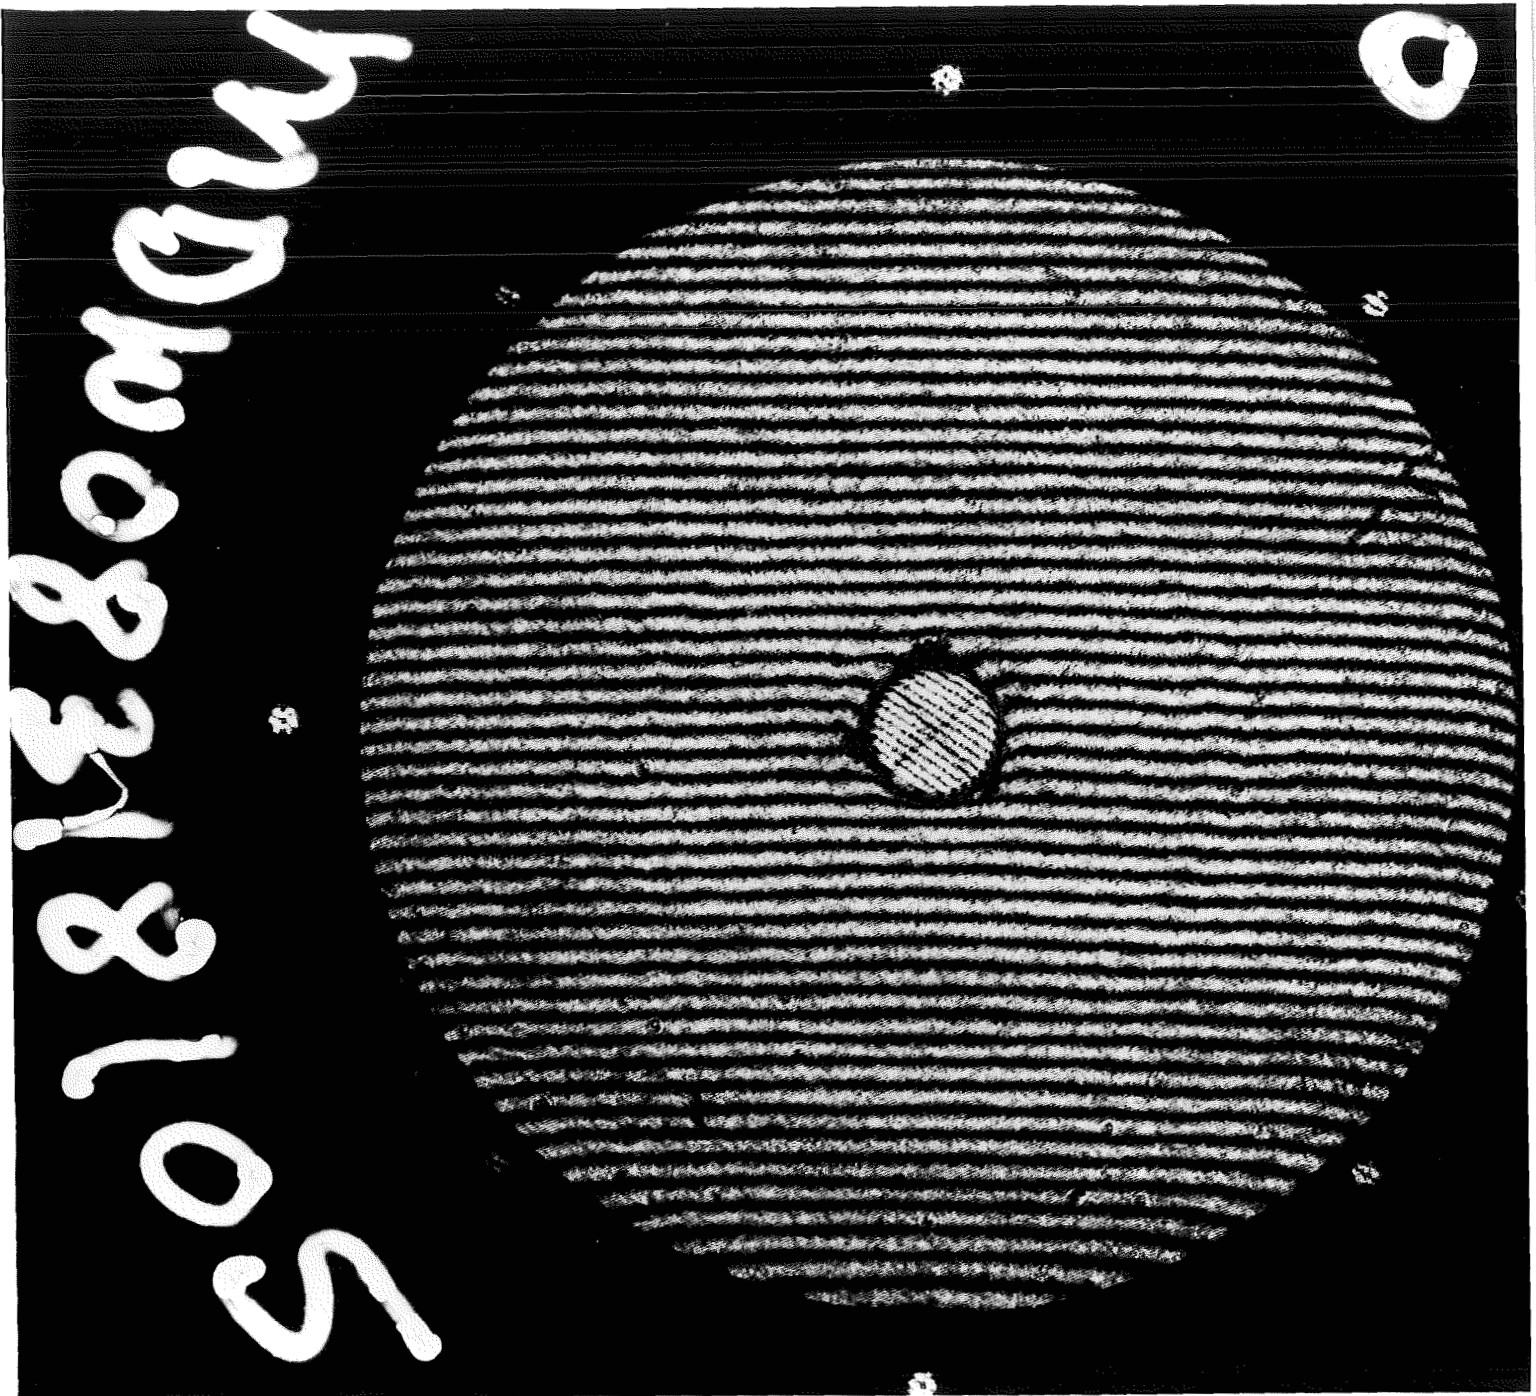
Figure D-4 is one of a set of interference fringes obtained from the flight secondary mirror at the completion of fabrication. A Hindle Shell test, which uses a double bounce off the surface of the secondary mirror, produced a distance between fringes corresponding to a surface-height variation of 0.25 wave. The secondary mirror is quite smooth, with an rms surface error of 0.012 wave. The small circular zones have an error of about 0.018 wave peak-to-valley at 632.8 nm. Because of the double bounce, the appearance of the fringes doubles the effective wavefront error that this component introduces into the system.

An interferogram alone cannot be used to determine the absolute surface shape, that is, the radius and conic constant, of the mirror. The adjustment of the test setup must be controlled to determine this base surface. However, in the fabrication process, the aspheric surface figure was tested by fringe counting against a standard spherical test plate. The setup parameters of the Hindle Shell test were dimensionally controlled to set the absolute conjugates, thereby controlling the reference asphericity of the secondary mirror. The interferogram in Figure D-4 shows essentially no residual spherical aberration. This independent verification during fabrication makes it plausible to assume that no gross error in asphericity exists. Test data analysis at the time concluded that the tolerances had been met.

Analysis of this interferogram in 1990 supports, with only minor differences, the predicted quality of the surface shape.

Figure D-4. Hindle Shell interferogram of the secondary mirror, taken August 31, 1981.
